Lac des Seize-Îles 2022 Report

Assessment of ecological/biological trends

Municipalité Lac-des-Seize-Îles
Friends of the Lake, Lac-des-Seize-Îles

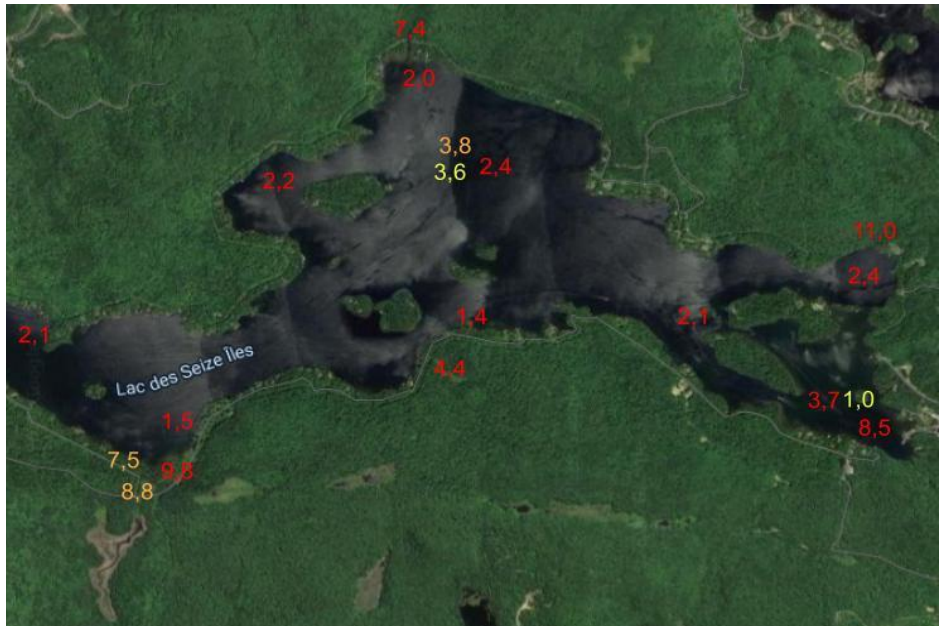
Figure 3: Phosphorus measurements in µg/L in 2020 (red), 2021 (orange) and 2022 (yellow)

The phosphorus concentrations varied little between samples taken throughout the entire lake (1.5 to 3.8 µg/L) with the exception of the bay near the outlet of the lake (3.7 and 8.5 µg/L), and in the main tributaries (7.2 to 11µg/L). Therefore, it can be assumed that the RSVL phosphorus measurements taken from the surface water above the deepest zone of the lake (zone number 10 as per appendix 1) allows fairly representative monitoring of the general water quality except at the southern end of the lake, and in the tributaries. It is not representative of what is found in the hypolimnion (mass of cold water under the thermocline) either. Samples taken near the thermocline at 4 different locations also revealed higher rates as shown in table 1 below. During a few dives, we also had observed a greater presence of algae.

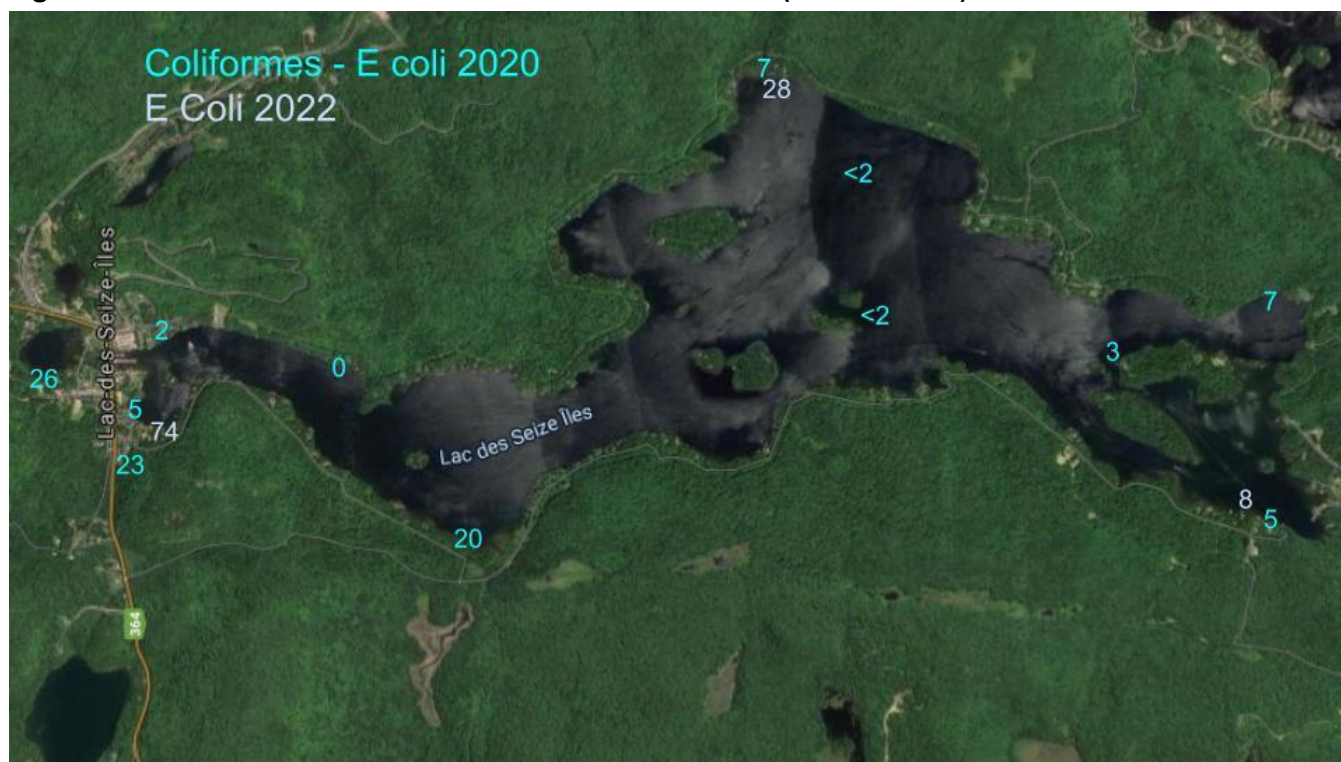
Figure 9 : Results for faecal coliform and E.coli counts (CFU/100 mL) in 2020 and 2022

The results indicated in figure 9 reflect that the quality of the water was good everywhere for swimming and recreational activities.

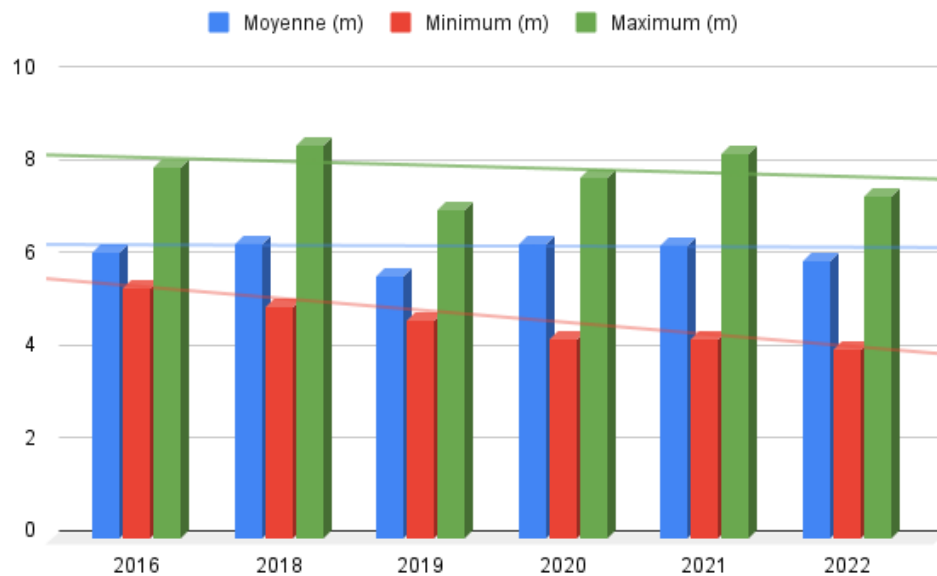
Figure 11 : Average, minimum and maximum measures and trend for transparency from 2016 to 2022

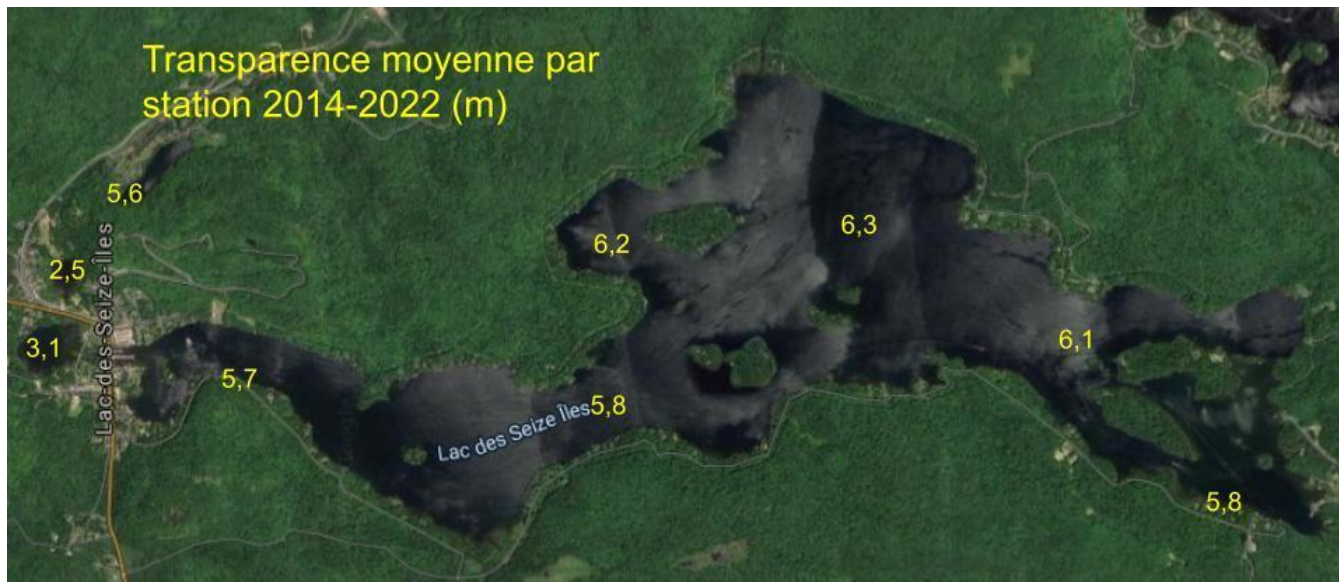
Figure 12 : Average of transparency measurements according to the different stations for the years 2014 to 2022

Note that the transparency varies between 5.7 and 6.3 depending on the different stations. The water of two small lakes (Lac du Grand-Héron and Baie des Soeurs) are tributaries of Lac des Seize-îles, but they are very different environments. Their transparency measurement results reflect this difference.

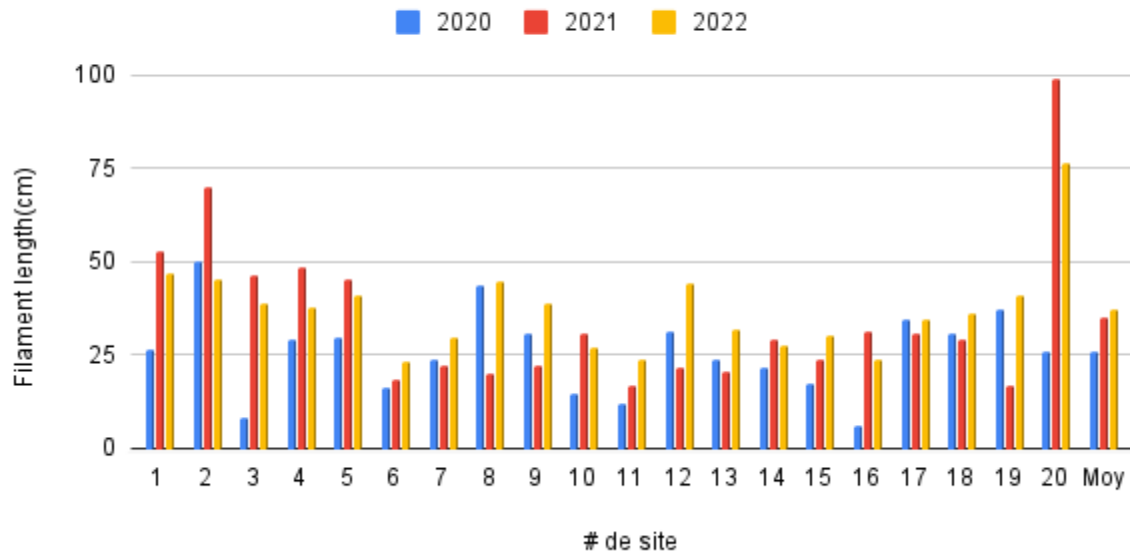
Figure 16 : Filament length variation for the 20 sites measured in the last three years

The length of the filaments vary from 0 to 18 cm. As for that of the periphyton, we observe that the average length of the filaments increased from 2020 to 2022.

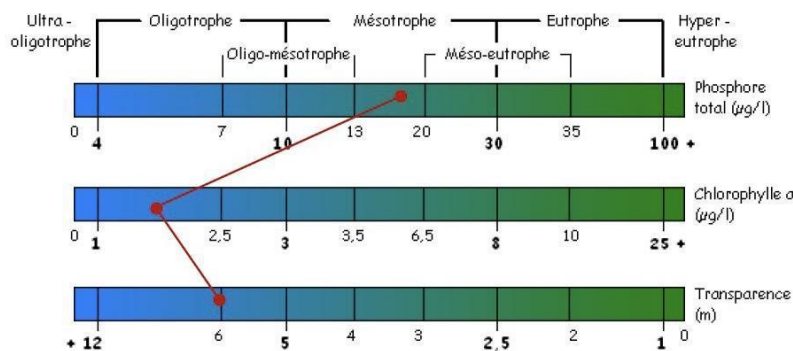
Figure 18 : Determination of the trophic level ranking of Lac des Seize-Îles in 2011 (Biofilia report)

If we compare the two graphs from figure 18 and figure 19, we could conclude that Lac des Seize-Îles has remained in the oligotrophic level ranking. However, as mentioned previously, the phosphorus concentrations measured in 2011 are very high, making it difficult to compare to the situation of today.

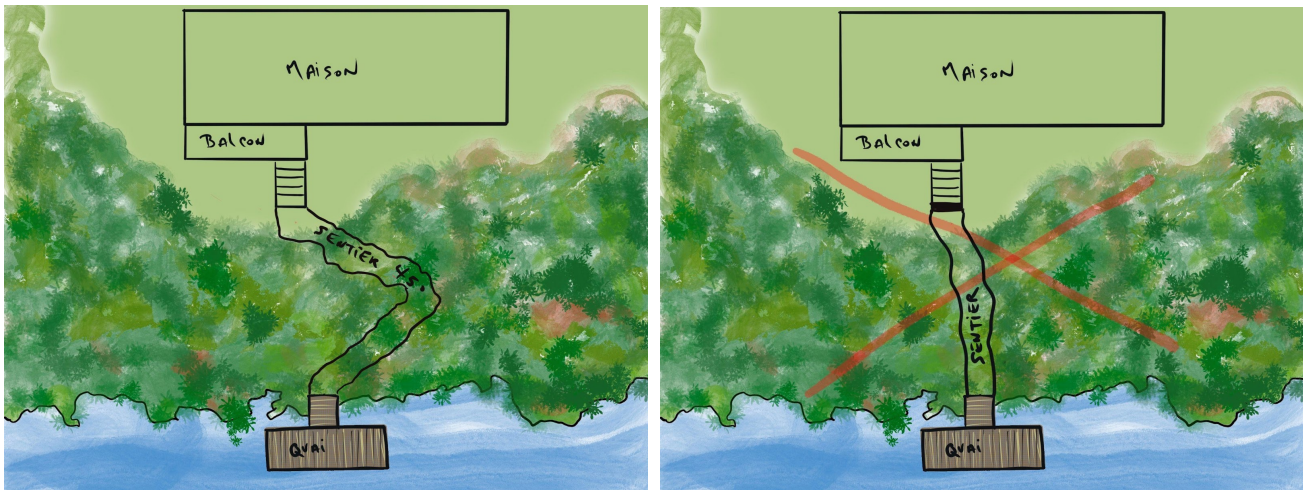
Figure 24 : Good configuration of an access trail in a shoreline protection strip and example of what to avoid.

All lake residents want to have their own private access to the lake without sharing with their neighbors. For this reason, it is permitted to open a trail no more than 1.2 metres wide that leads to an opening to the lake of no more than 5 metres wide. But the access trails risk breaking the effectiveness of the shoreline protection strip. In order to cause as little disruption as possible, it is best to develop it taking into account the slope of the shoreline.

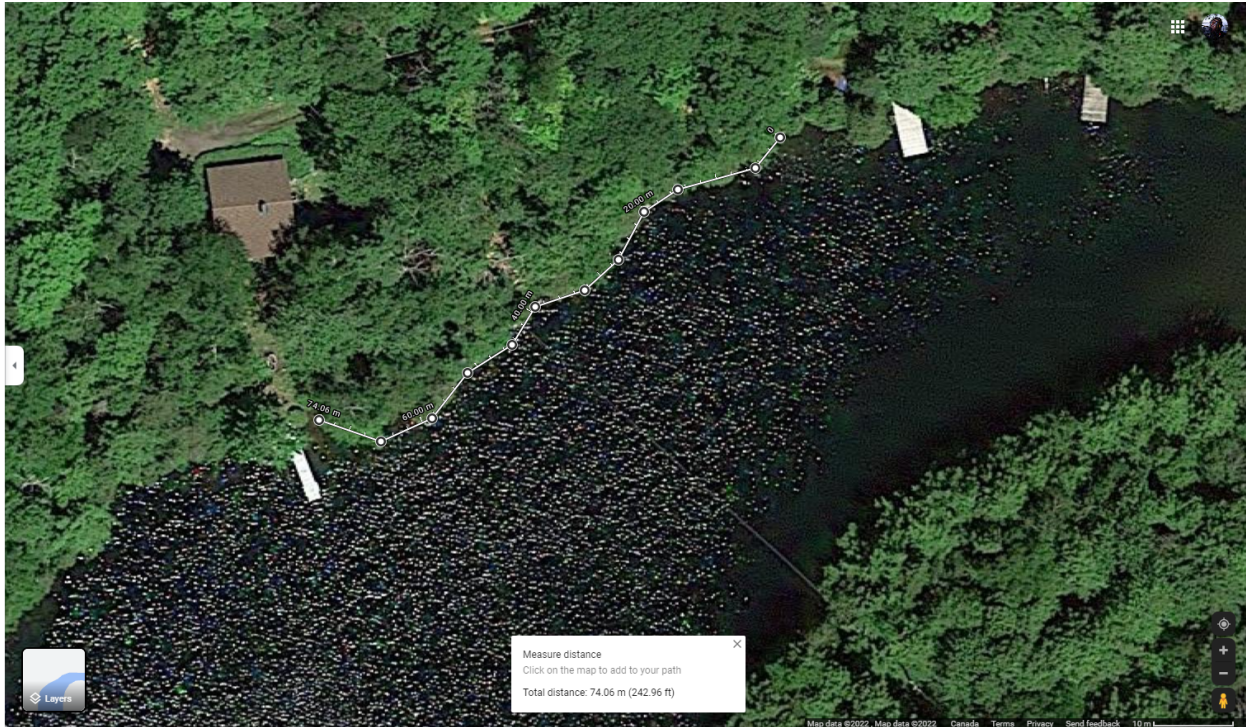
Figure 25 : Example of undisturbed shoreline representing one homogenous zone.

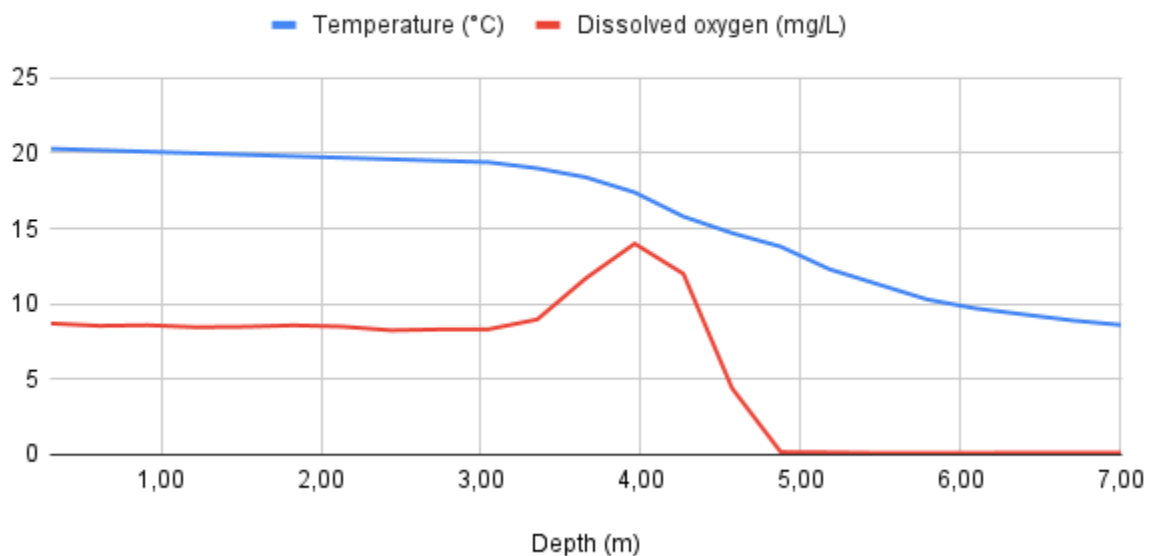
Figure 30 : Temperature and dissolved oxygen profile at Baie des Soeurs on August 2, 2021

As seen in figure 30, the concentration of dissolved oxygen becomes null a little below 5 metres in depth. The bottom of this small lake is covered with a thick layer of black sediment. The condition of anoxia (lack of oxygen) is a sign that many microorganisms are breaking down the sediments and consuming all the oxygen present before the end of summer (before fall water mixing). This situation, however, is not new as Biofilia mentions similar results in their 2012 report.

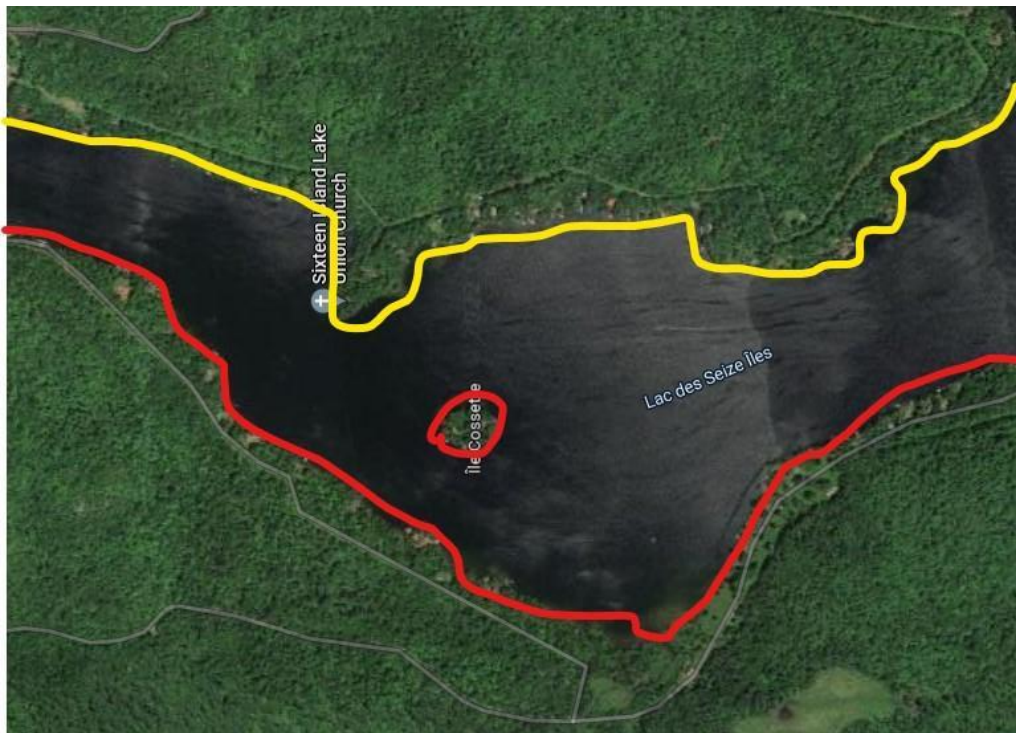
Figure 37 : North part of the lake for the characterization of the riparian protection strips. What is considered the East bank is highlighted in Yellow and the West bank is highlighted in Red.

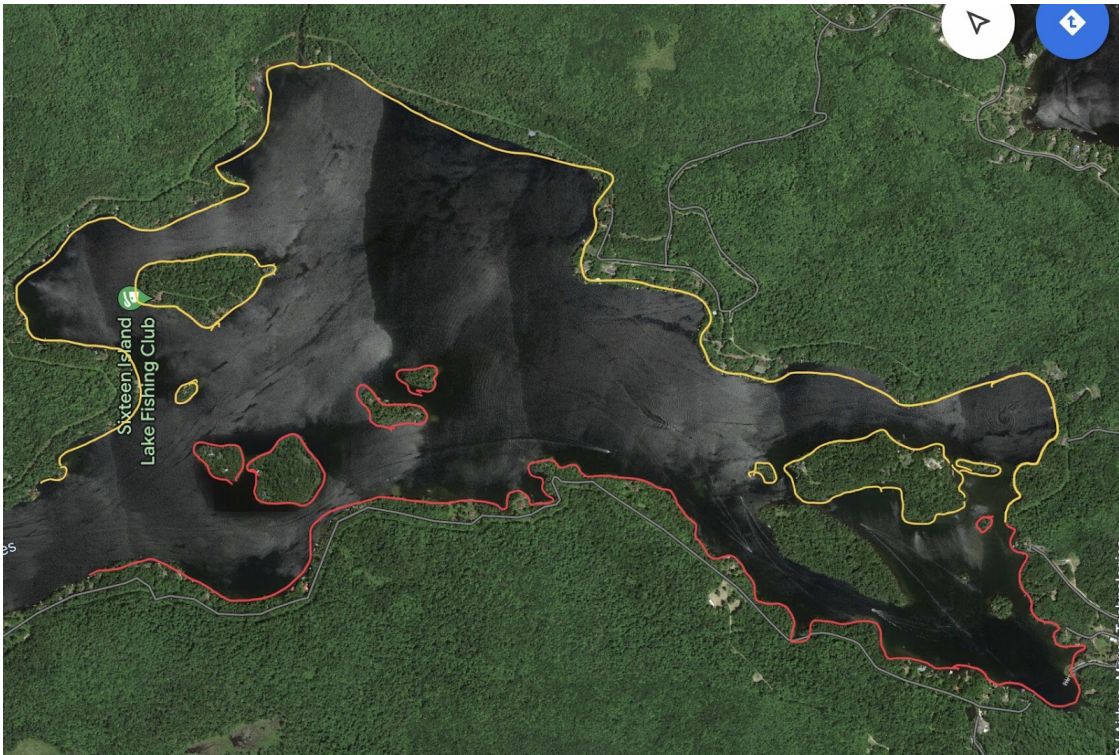
Figure 40 : Southern part of the lake for the characterization of the riparian protection strips. What has been integrated into the coast of the East bank is underlined in Yellow and what has been integrated into the coast of the West bank is underlined in red.

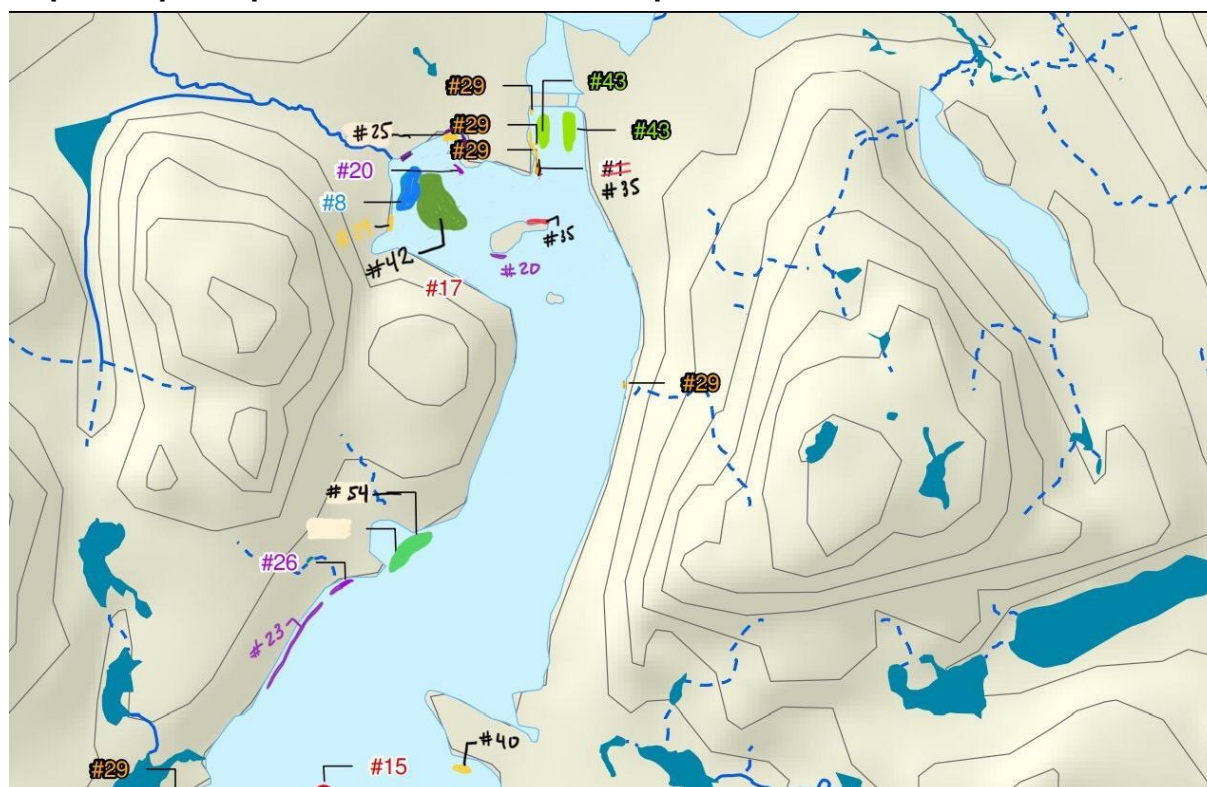
Map 2 : Aquatic plant beds in the northern part of the lake in 2022
